CALSPAN REMOTE AIR BAG DEPLOYMENT INVESTIGATION

[REDACTED] CALSPAN CASE NO. 93-7

VEHICLE - 1993 VOLVO 850 GLT

ACCIDENT DATE - [REDACTED], 1993

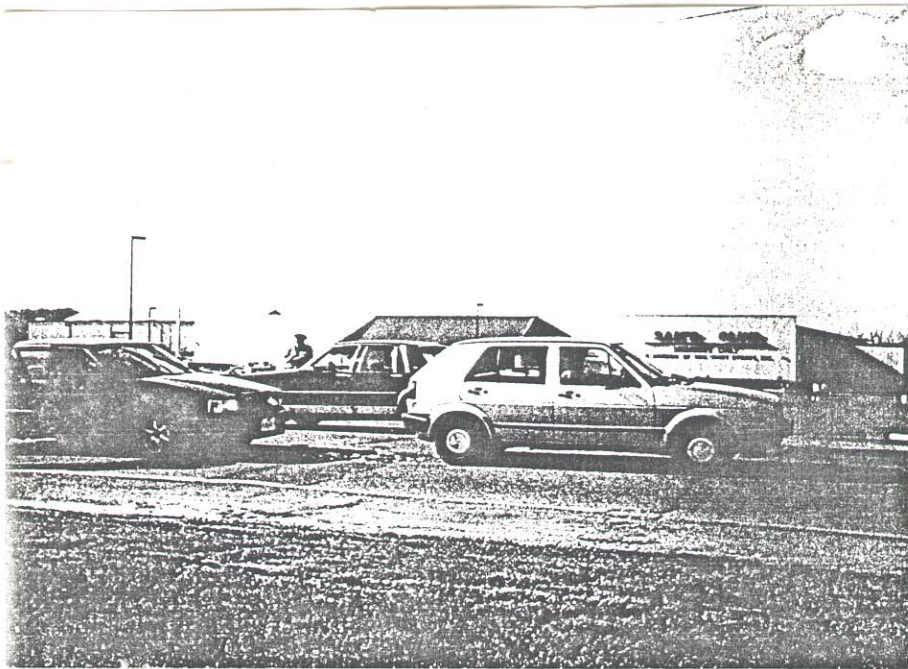
1

Final Rest Positions of the Involved Vehicles

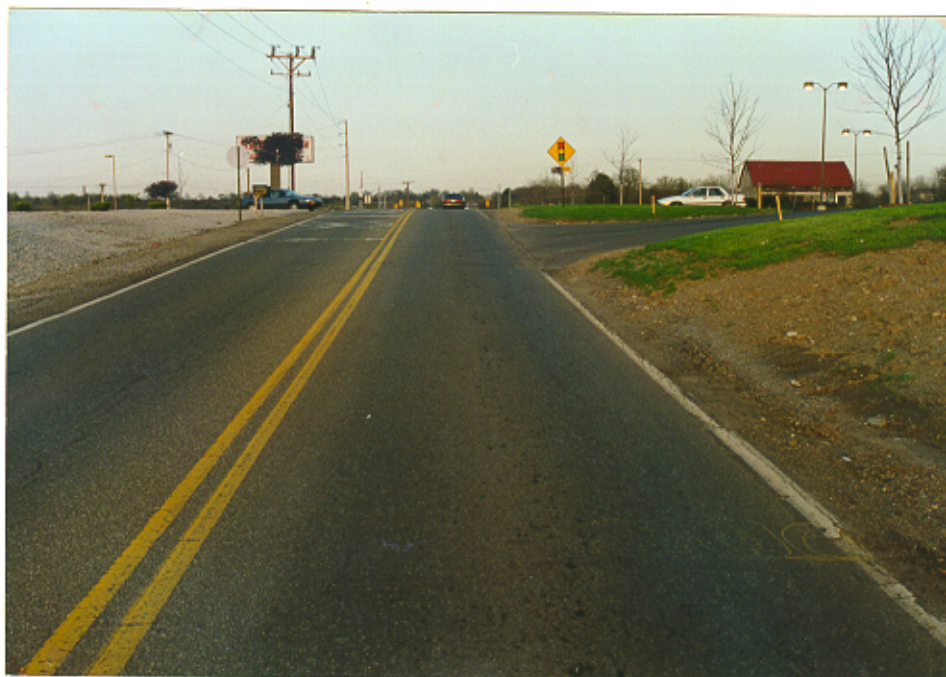
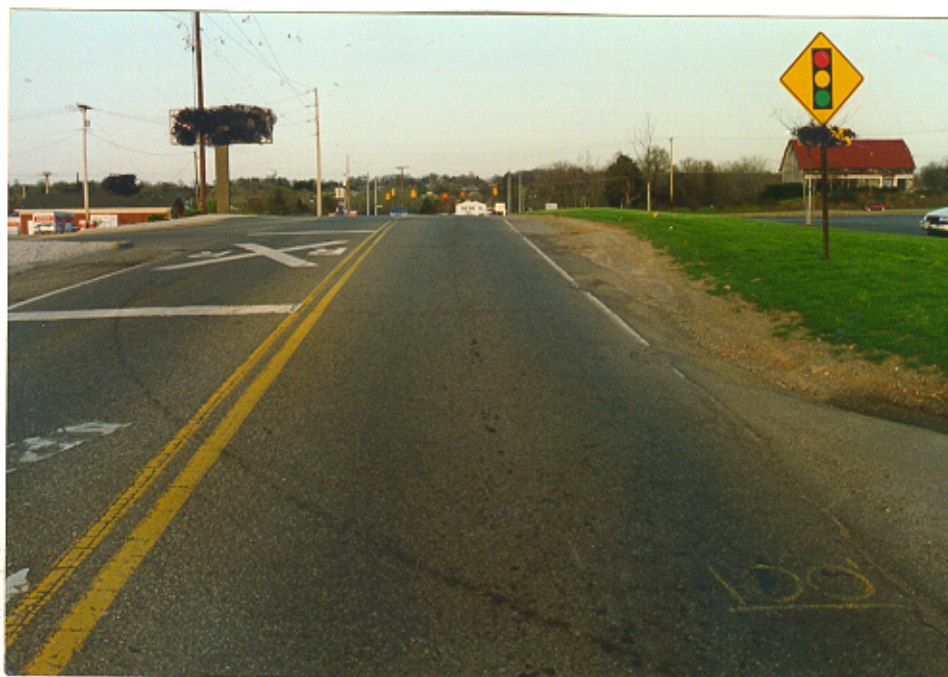
3

Pre-Crash Trajectory of the Volvo 850 GLT

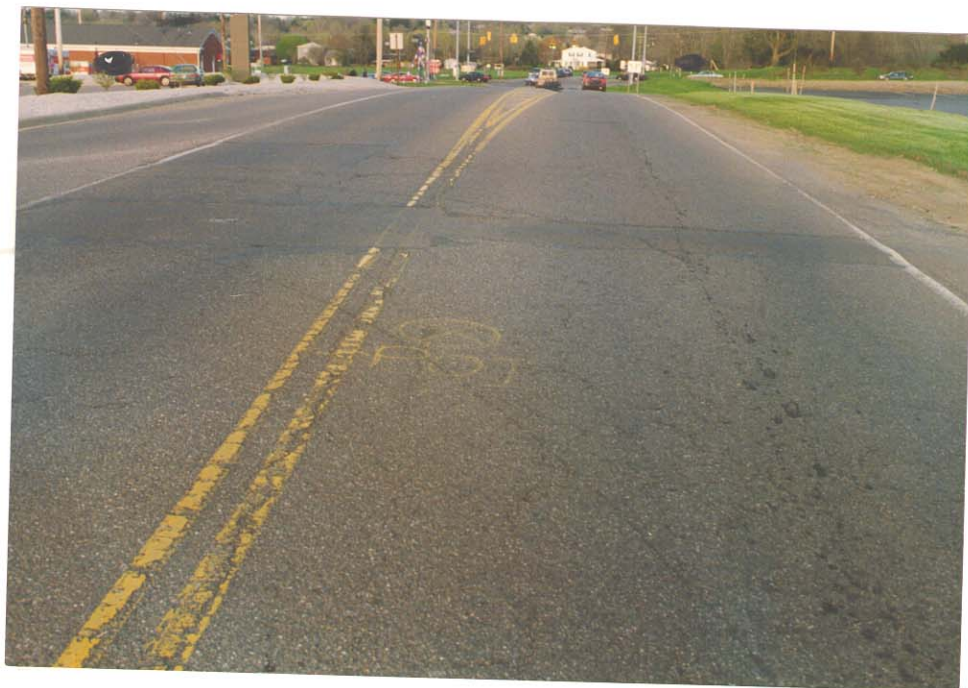
5

Point of Impact

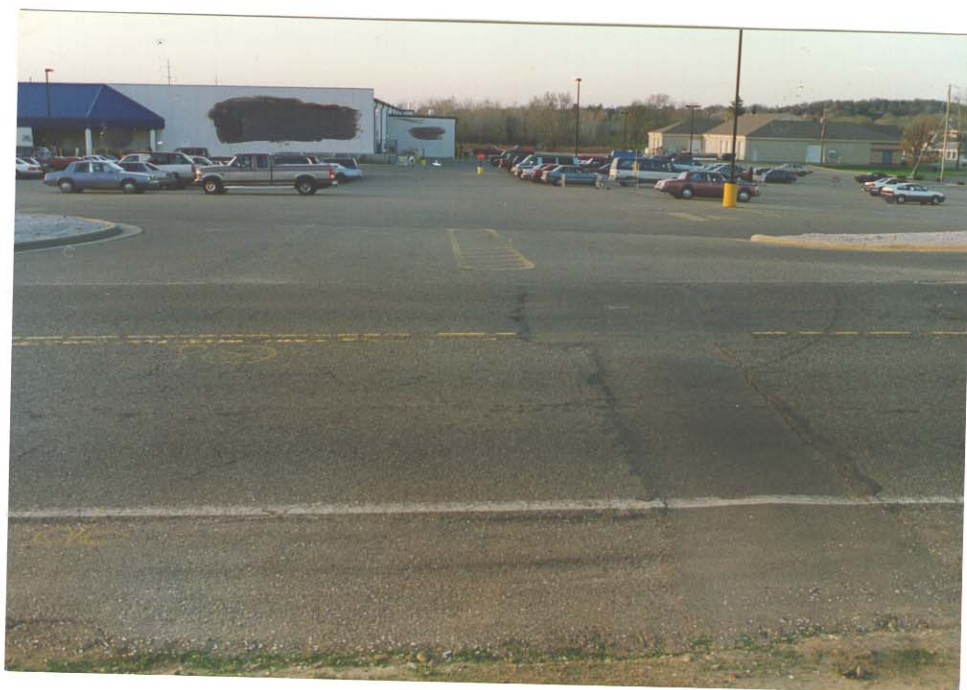
6

Perpendicular View of the Crash Scene and Driveway

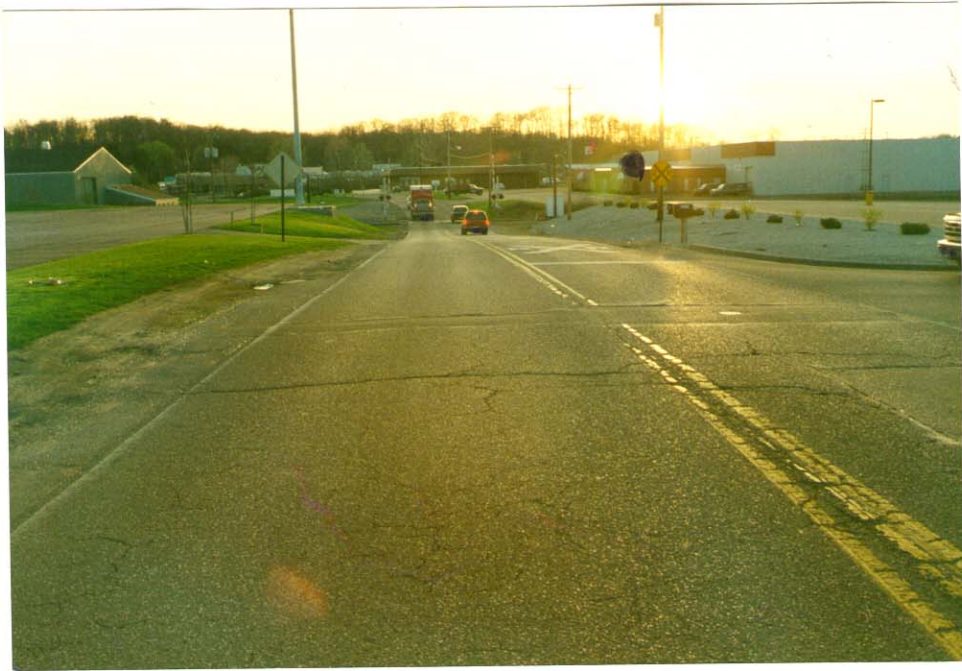
7

Lookback View of the Crash Scene

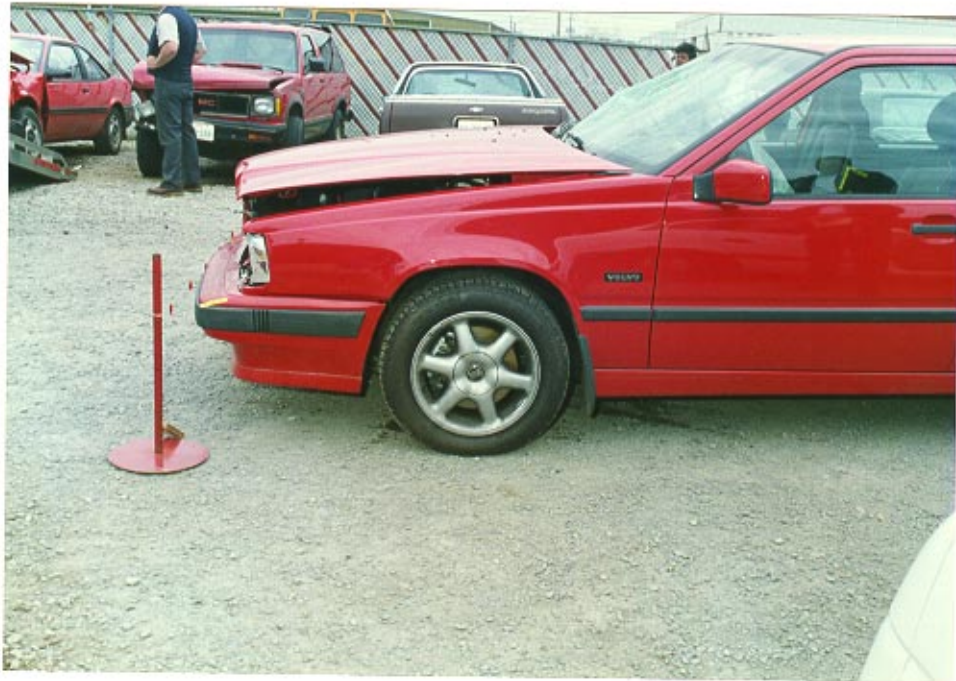
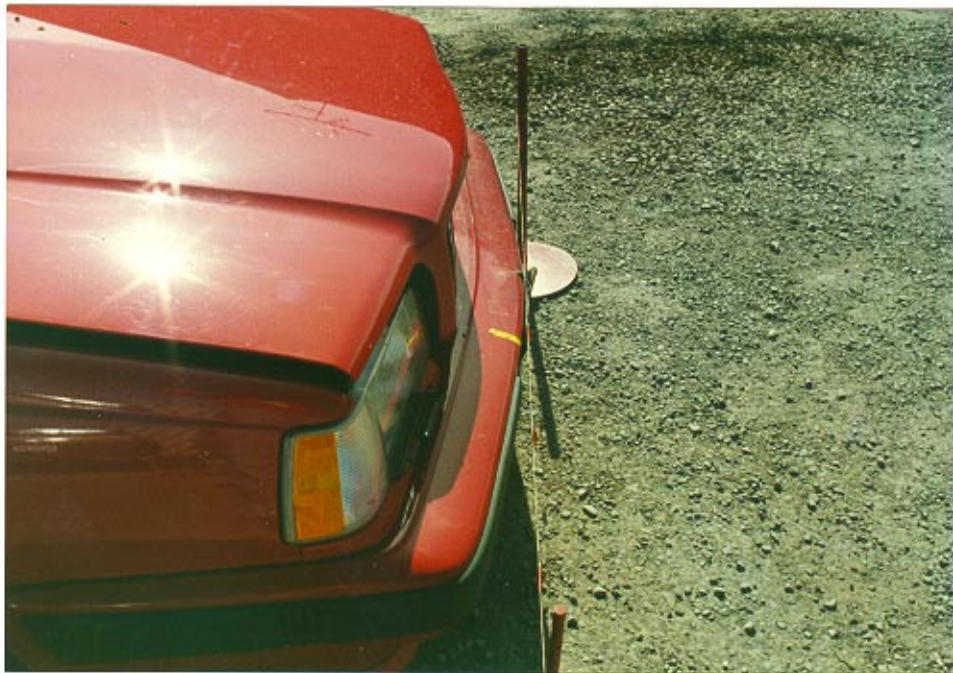
11

The front to rear impact sequence resulted in a 12 o'clock impact force to the Volvo and a 6 o'clock impact force to the struck Volkswagen. Although crush was minimal, and involved only sheetmetal components of the Volvo, velocity changes were computed by the damage algorithm of the CRASHPC program at 12 km/h (7 mph) for the Volvo and 17 km/h (11 mph) for the Volkswagen Golf. (A copy of the CRASHPC output is included as Appendix B of this report.) As a result of the impact-induced deceleration, the Volvo's Supplemental Restraint System deployed.

Perpendicular Views Showing the Extent of Crush to the Volvo

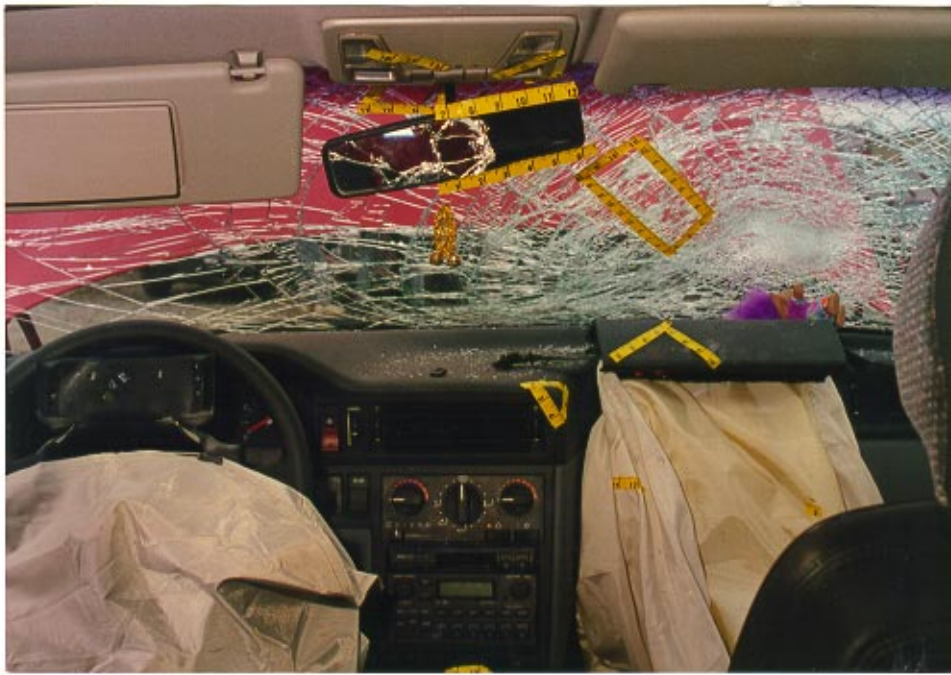
17

Overall Interior View of the Deployed Dual Air Bags and Subsequent Occupant Contact Points

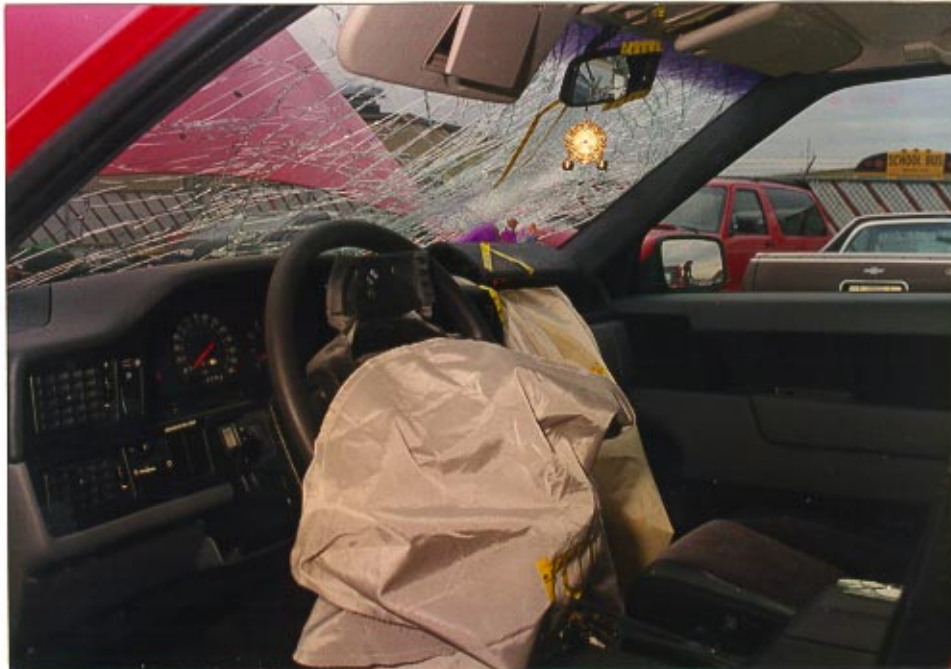
18

Deployed Driver's Side Air Bag

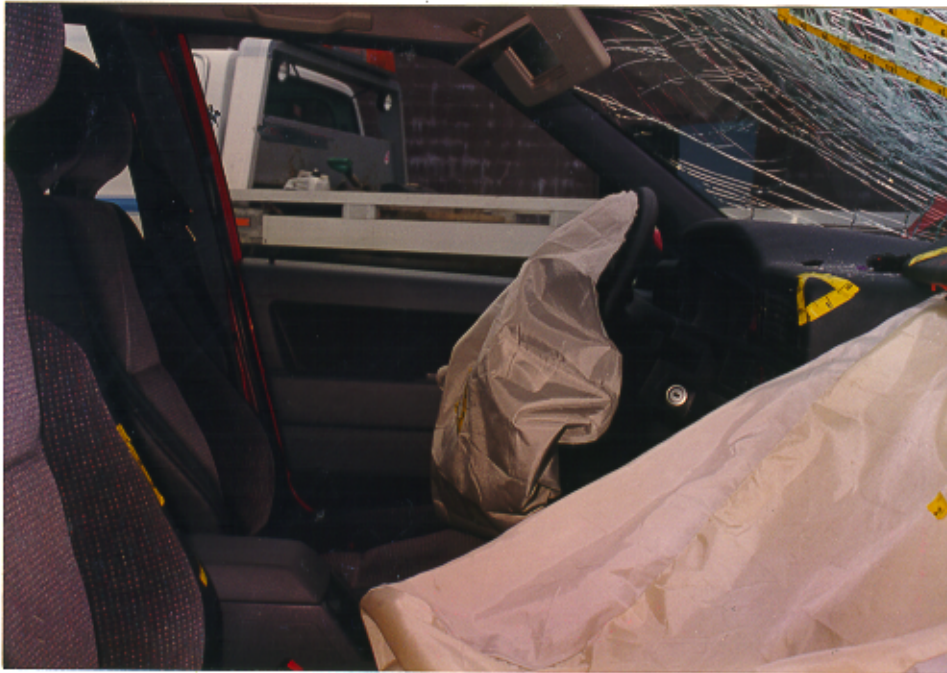
19

The petite female driver of the Volvo 850 GLT was in a presumed forward driving position. At the time of our inspection of the Volvo, the driver's seat track was apparently readjusted from its crash position and was 1.3 cm (0.5") forward of the full rearward position. The seat back was adjusted to an angle of 75°, 15° rearward of vertical. The power seat track had approximately 23 cm (9") of fore and aft adjustment. The Volvo was also equipped with a tilt and telescopic steering assembly that was found adjusted to the full forward position. The driver was not wearing the manual 3-point lap and shoulder belt system. The driver's side belt system was equipped with a pyrotechnic pretensioner that fired with the SRS. The pretensioner spooled-up the slack of the stowed belt and locked the system against the left B-pillar. In addition, the driver of the Volkswagen noted that the Volvo driver was not wearing the belt restraint as he approached the Volvo immediately following the crash.

Perpendicular View of the Deployed Driver's Side Air Bag
and Fully Retracted and Locked Manual 3-Point Belt System

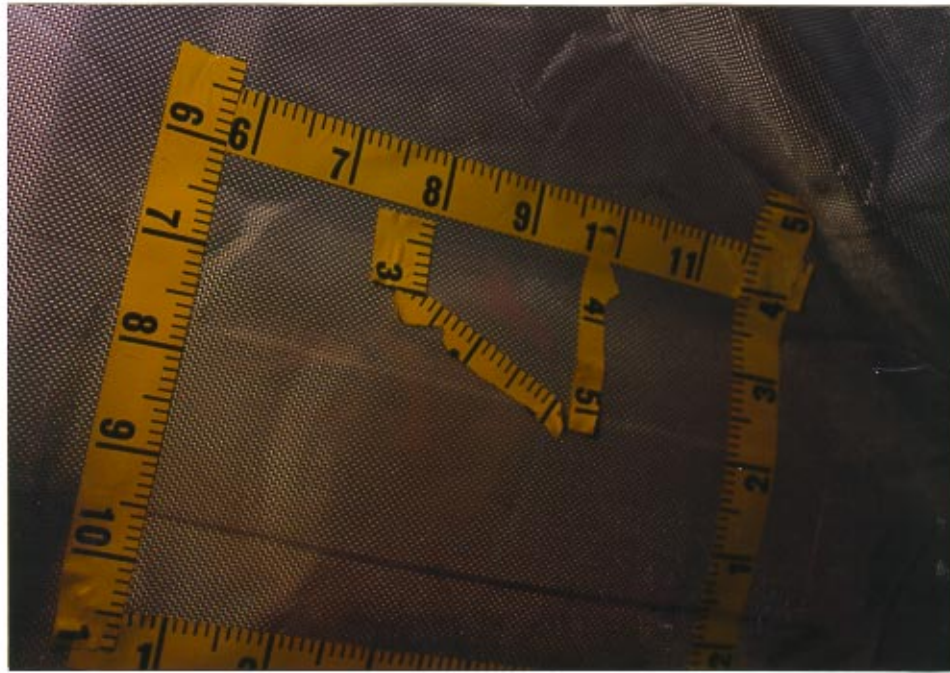
21

Close-up View of Driver's Facial Contact, Lipstick and Makeup Transfers

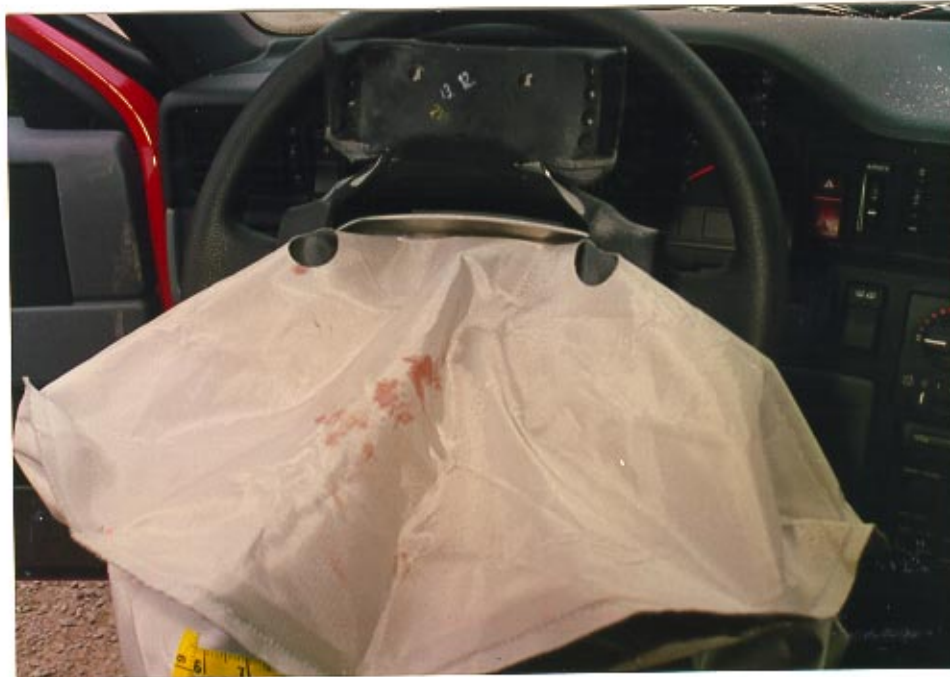
22

Upper Air Bag Module Cover Flap with Sheetmetal Reinforcement
and Upper Venting Ports at the 10 and 2 O'clock Positions

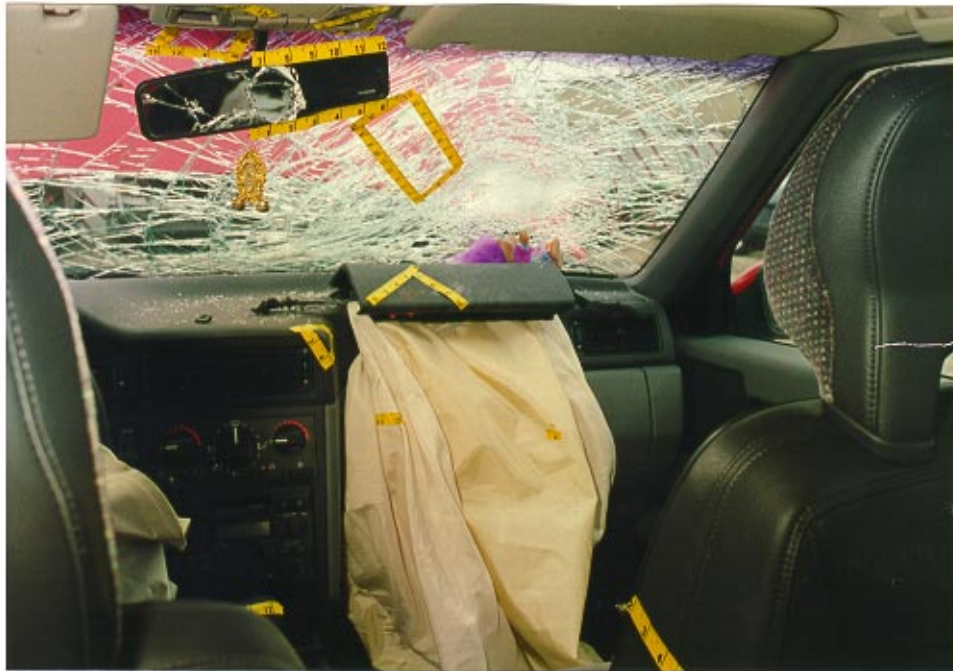
27

Trajectory and Subsequent Contact Points of the Child Passenger

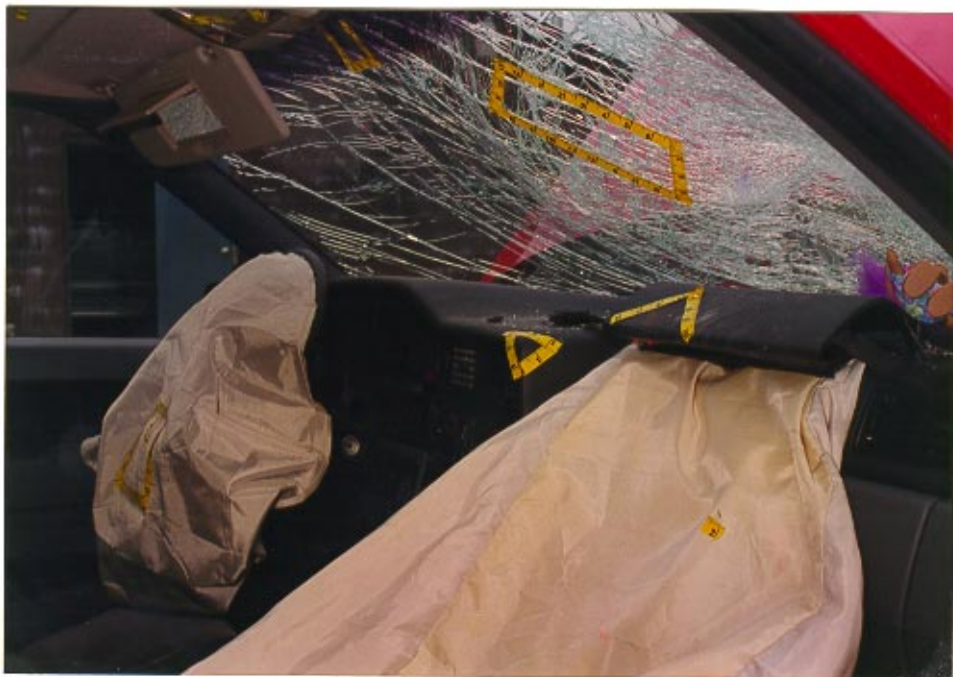
28

Right Front Passenger Air Bag Module Cover Flap and Deployed Air Bag

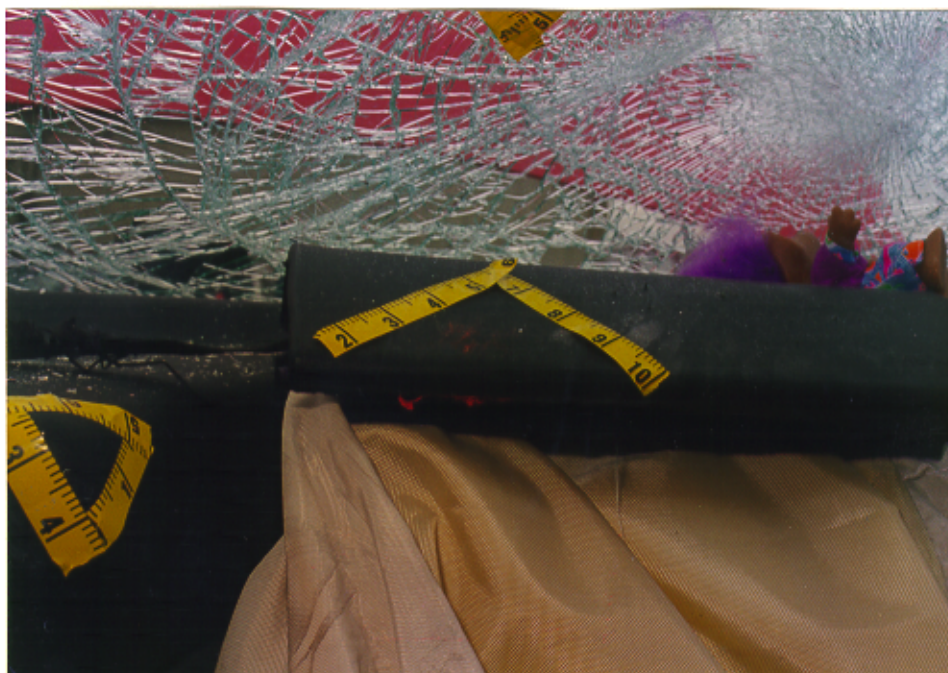
29

Fabric Transfer Extends 2" Vertically Onto Face of Module Cover Flap

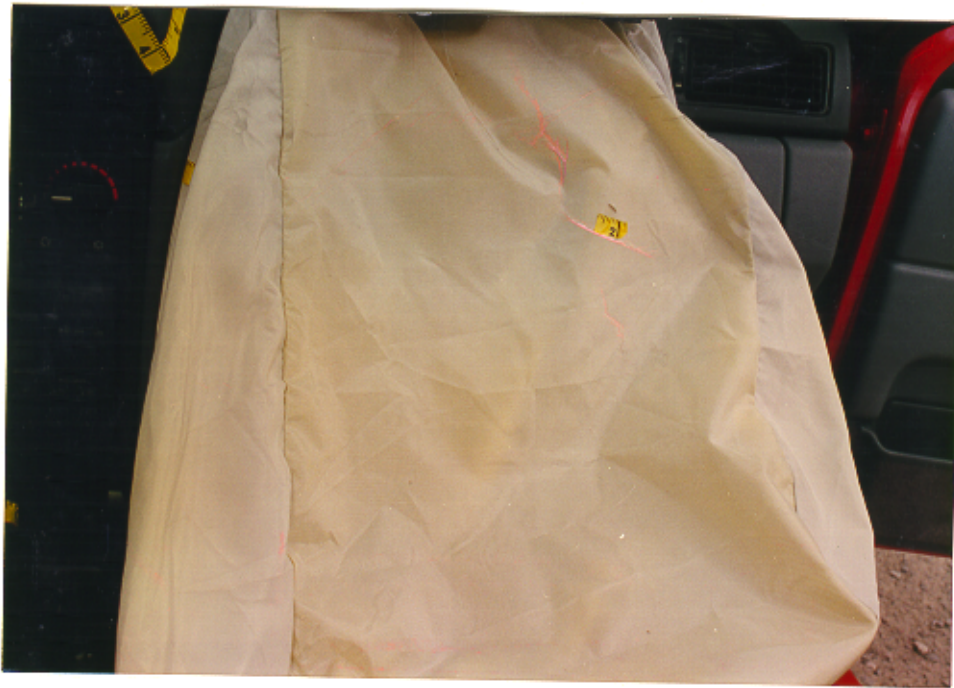
31

There was a small 9.5 mm (0.4") diagonally orientated tear at the top surface of the passenger bag. The tear was located 28 cm (11") from the module and 12.7 cm (5.0") inboard of the lower right seam. The edges of the tear appeared to be discolored (darkened), similar to exposure to heat or the hot gases venting through the tear. There was no other damage or occupant contact evidence to the passenger air bag.

Passenger Side Air Bag

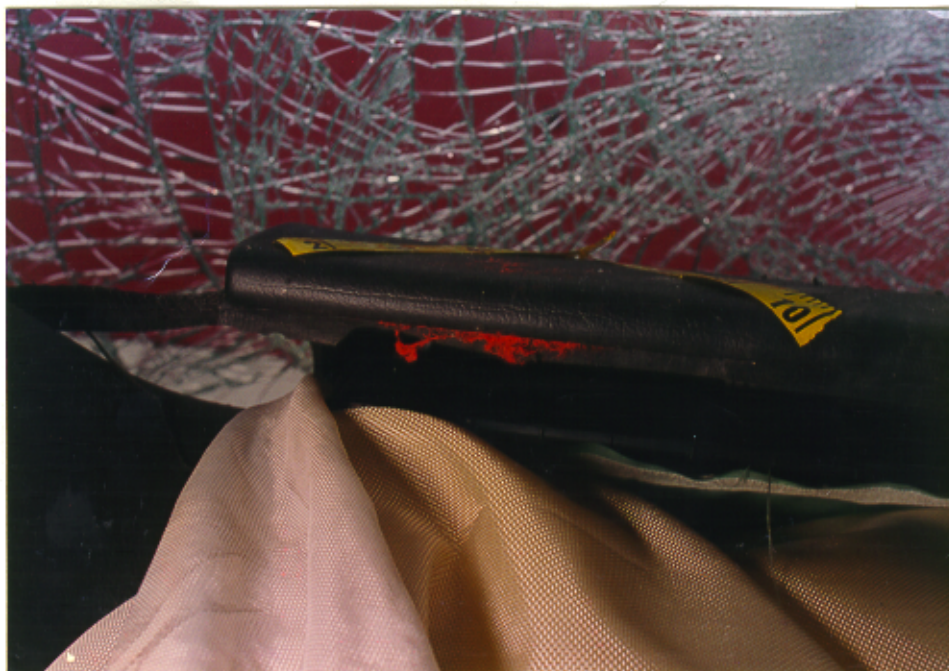
32

Orange Fabric Transfer on the Leading Edge of the Passenger Air Bag Module Cover Flap
that Resulted from Contact with the Child Passenger's Jacket

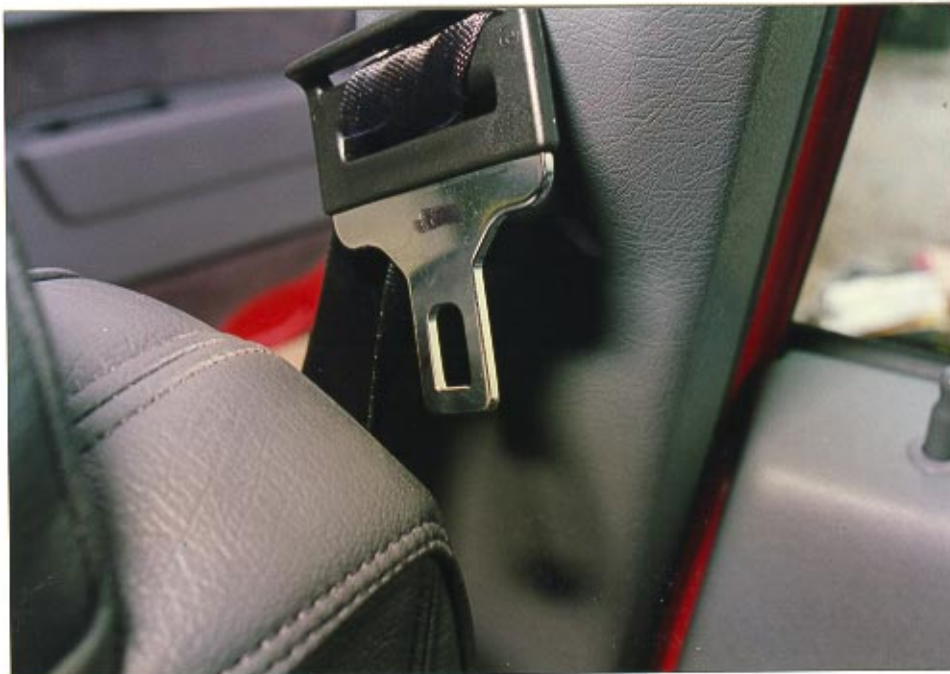
42

Bag Deployment of the SRS Pretensioner

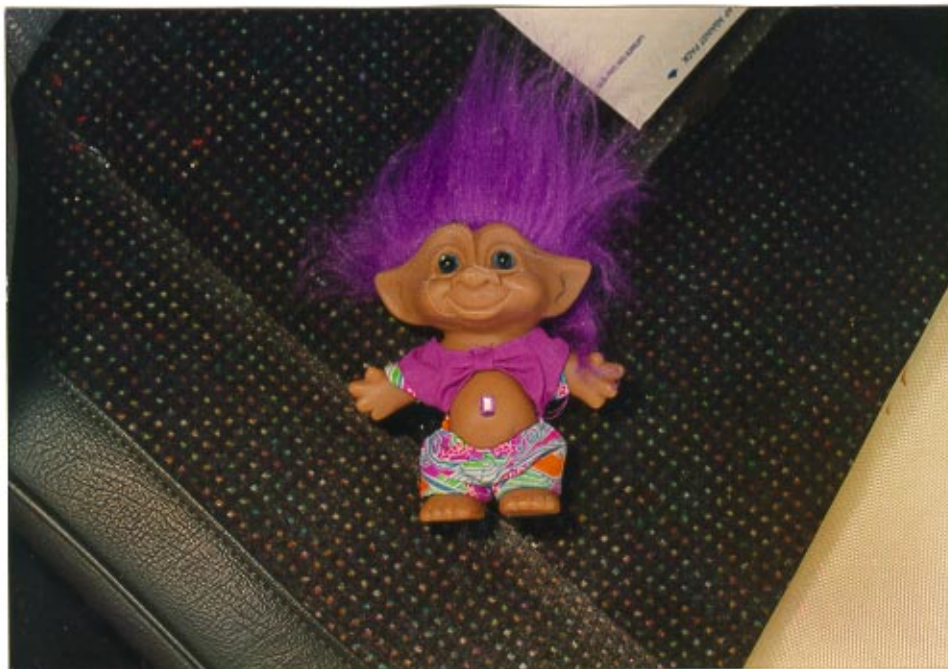
46

Glass Abrasion to the Face of the Troll Doll

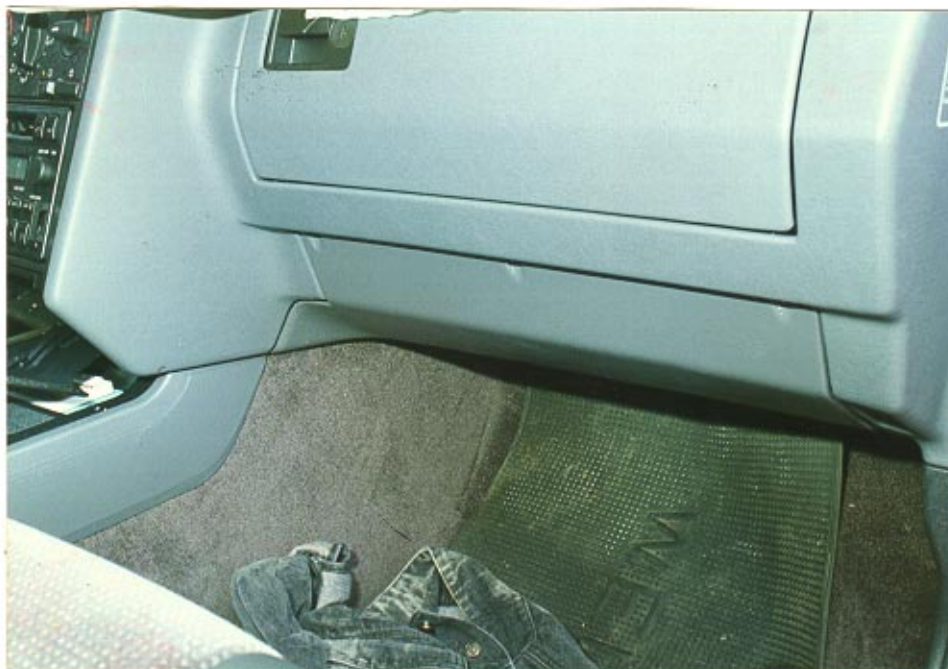
47

Child Passenger Came to Rest on Right Front Floor
with Head Resting on Right Front Seat Cushion

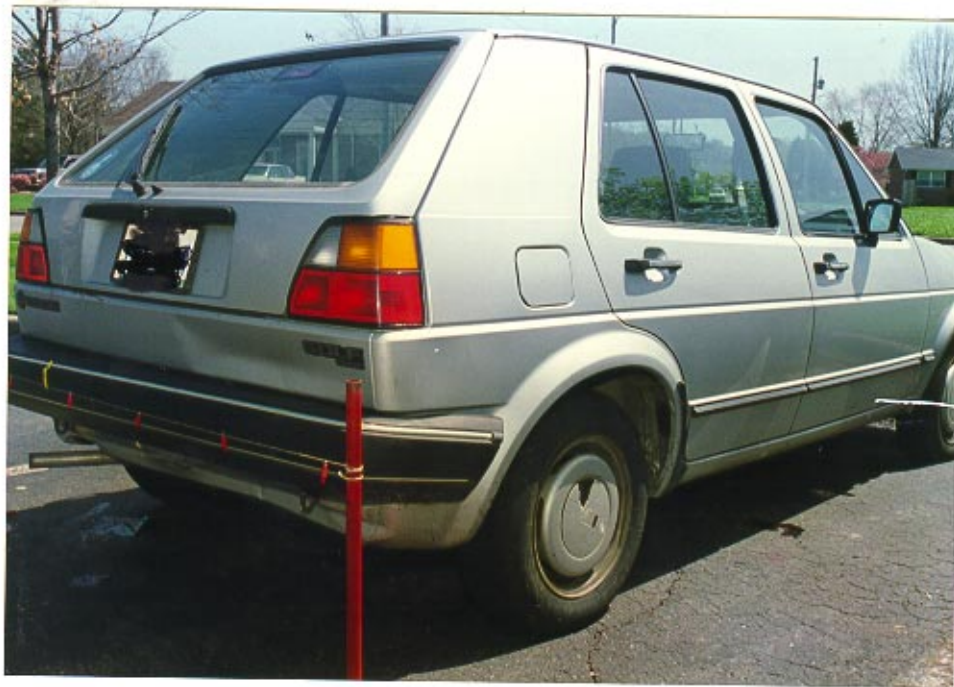
49

Right Rear Three-Quarter View

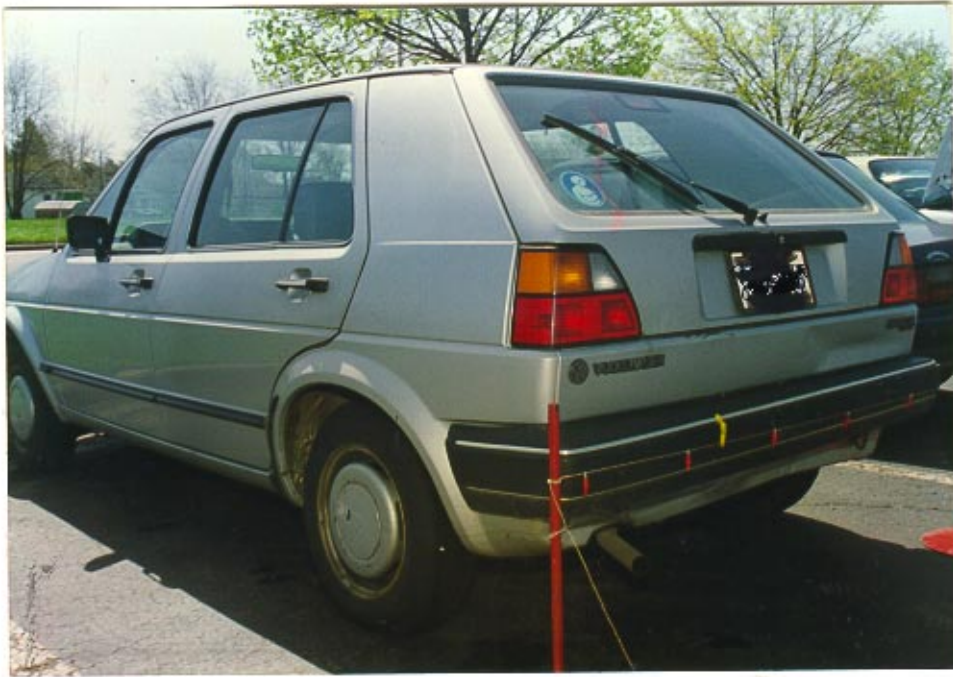
52

Direct Contact Damage Begins 12.25" Left of Center
and Extends 41.4" to the Right Rear Bumper Corner

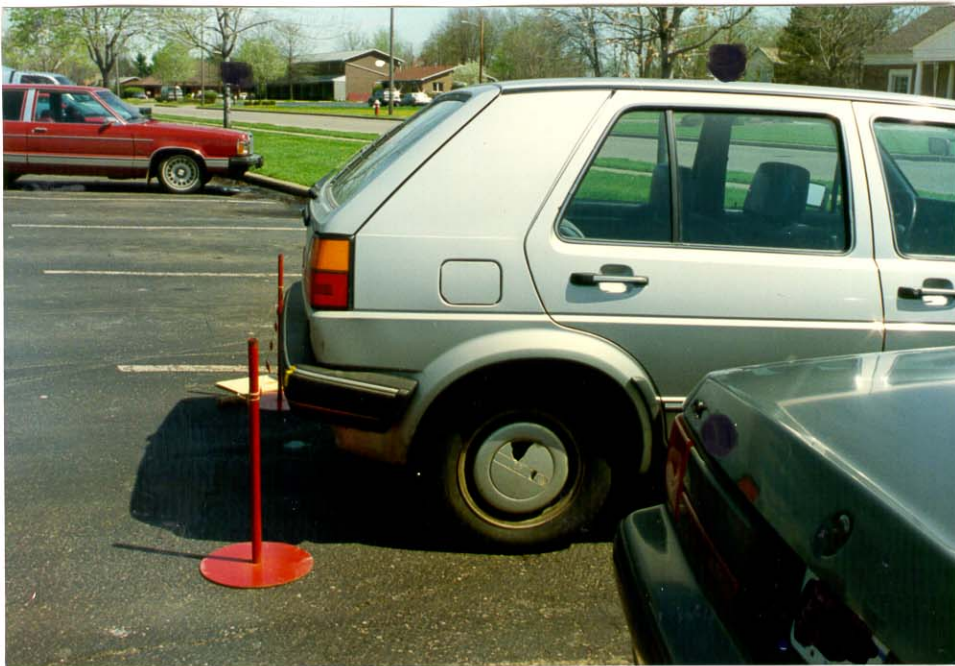
54

Perpendicular View at the Left Rear Corner Showing the Extent of Crush

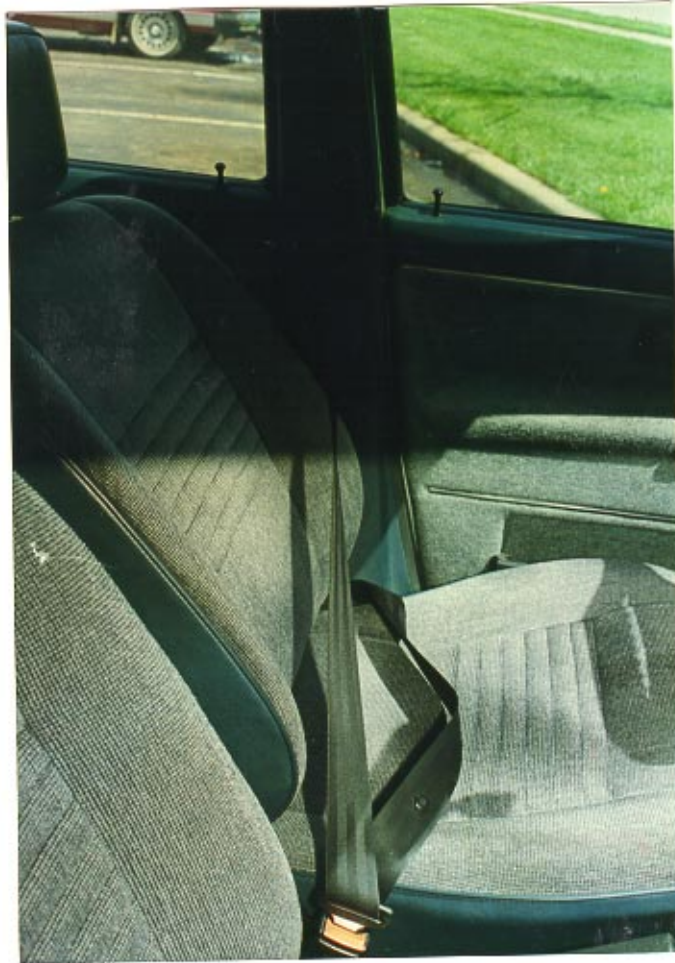
56

Overall View of the Driver's Seated Area
